Contract #: 04-0120F4Cty: SF/ALA Rte: 80 PM: 13.2/13.9File #: 69.28**WELDING INSPECTION REPORT****Resident Engineer:**Siegenthaler, Peter**Address:** 333 Burma Road**City:** Oakland, CA 94607**Report No:** WIR-019770**Date Inspected:** 14-Jan-2011**Project Name:** SAS Superstructure**OSM Arrival Time:** 1500**Prime Contractor:** American Bridge/Fluor Enterprises, a JV**OSM Departure Time:** 300**Contractor:** Zhenhua Port Machinery Company, Ltd (ZPMC), Changxing Island **Location:** Shanghai, China**CWI Name:** See Below**CWI Present:** Yes No**Inspected CWI report:** Yes No N/A**Rod Oven in Use:** Yes No N/A**Electrode to specification:** Yes No N/A**Weld Procedures Followed:** Yes No N/A**Qualified Welders:** Yes No N/A**Verified Joint Fit-up:** Yes No N/A**Approved Drawings:** Yes No N/A**Approved WPS:** Yes No N/A**Delayed / Cancelled:** Yes No N/A**Bridge No:** 34-0006**Component:** OBG**Summary of Items Observed:**

WELDING INSPECTION REPORT

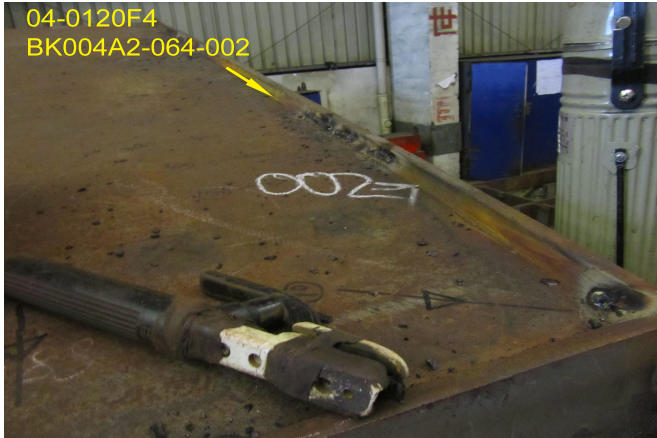
CWR2751-R0

Weld-BK004A2-064-002, 013, 021

WPS-345-SMAW-2G(2F)-Repair

The following digital picture illustrates typical CWR2751-R0
